**Flood Control Project Maintenance
Levee Inspections**

Maintenance Issue Types Only, Levee Inspection Report By Mile - Spring 2019

Reclamation District No. 0827 Elkhorn

Waterway	Bank	Unit Miles	Inspection Start/End	Inspector
Unit No. 01 Sacramento River	Right	1.34	03/07/2019 03/07/2019	Zach Jojola

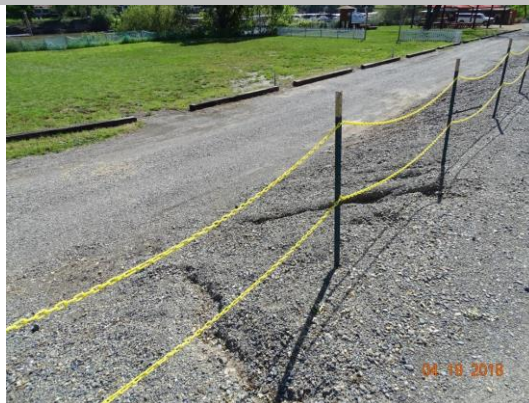
Photo 1 of 1 : SP_2019_RD0827_187_6_20190304_00004.jpg

LM Start	0.04	Rating **	A/W	Issue No.	6
LM End	0.04	Issue Type +	Ma	Location *	WS
Category	Earthen Levee			GPS Latitude/Longitude	
				Start	End
Item	Erosion / Bank Caving			38.674833 °	38.674833 °
				-121.630039 °	-121.630039 °
DWR ID	DWR_RD0827_01_s_2018_6				
Comment Code					
E1 : Note and monitor erosion site.					
Inspector Comment					
Small rills beginning to form on waterside slope. Recommend monitoring.

View of rills on the waterside slope. Spring 2018.

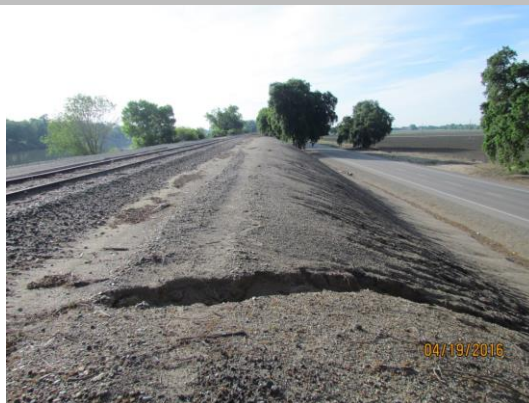
Photo 1 of 2 : SP_2019_RD0827_187_13_20190304_00009.jpg

LM Start	0.51	Rating **	M	Issue No.	13
LM End	0.51	Issue Type +	Ma	Location *	LS
Category	Earthen Levee			GPS Latitude/Longitude	
				Start	End
Item	Erosion / Bank Caving			38.669929 °	38.669929 °
				-121.623776 °	-121.623776 °
DWR ID	DWR_RD0827_01_s_2016_13				
Comment Code					
E2 : Schedule repair of erosion site prior to the next inspection.					
Inspector Comment					
Rills caused by rain.

View of the erosion on the landward side of the levee looking downstream. Spring 2016.

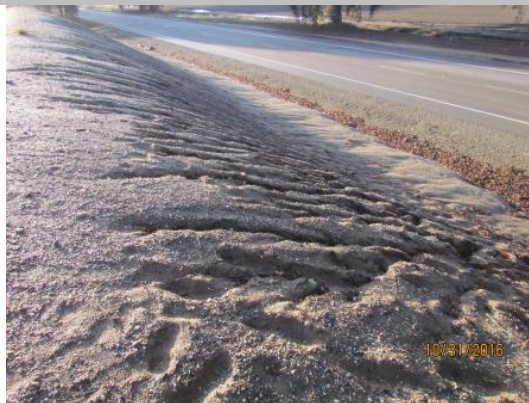
Photo 2 of 2 : SP_2019_RD0827_187_13_20190304_00010.jpg

LM Start	0.51	Rating **	M	Issue No.	13 (cont)	
LM End	0.51	Issue Type +	Ma	Location *	LS	
Category	Earthen Levee			GPS Latitude/Longitude		
				Start		End
Item	Erosion / Bank Caving			38.669929 °		38.669929 °
				-121.623776 °		-121.623776 °
DWR ID	DWR_RD0827_01_s_2016_13					
Comment Code						
E2 : Schedule repair of erosion site prior to the next inspection.						
Inspector Comment						
Rills caused by rain.

View of runoff erosion site. LS slope. Fall 2016.

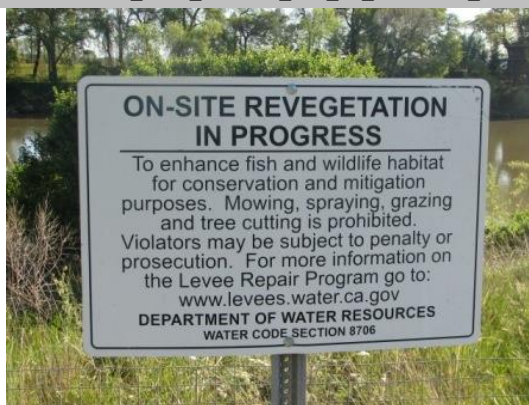
Photo 1 of 2 : SP_2019_RD0827_187_22_20190304_00013.jpg

LM Start	0.61	Rating **	A/W	Issue No.	22
LM End	0.92	Issue Type +	Ma	Location *	WS
Category	Earthen Levee			GPS Latitude/Longitude	
				Start	End
Item	Vegetation			38.668873 °	38.665750 °
				-121.622513 °	-121.618523 °
DWR ID	DWR_RD0827_01_s_2012_22				
Comment Code					
V8 : Environmental Requirements.					
Inspector Comment

Revegetation site spring 2012.

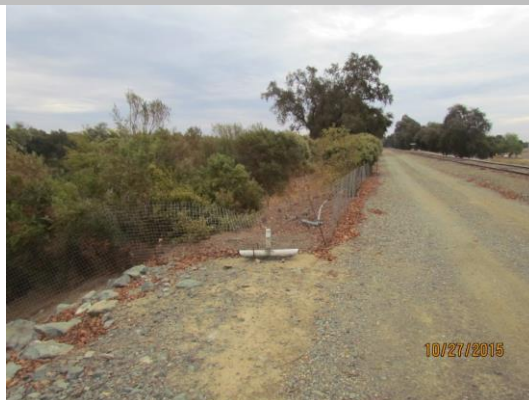
Photo 2 of 2 : SP_2019_RD0827_187_22_20190304_00014.jpg

LM Start	0.61	Rating **	A/W	Issue No.	22 (cont)
LM End	0.92	Issue Type +	Ma	Location *	WS

View of the revegetation site on the waterward side of the levee looking downstream. Fall 2015.

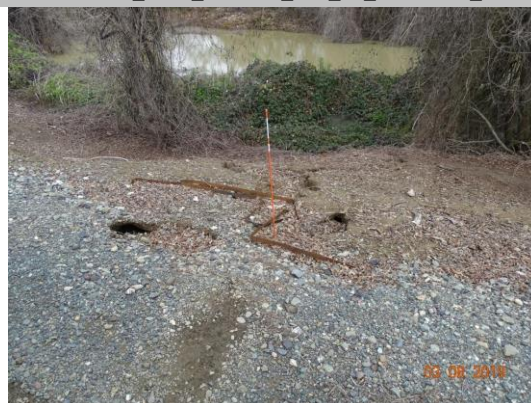
Photo 1 of 1 : SP_2019_RD0827_187_17_20190311_00018.jpg

LM Start	1.09	Rating **	M	Issue No.	17
LM End	1.09	Issue Type +	Ma	Location *	WS
Category	Earthen Levee			GPS Latitude/Longitude	
				Start	End
Item	Erosion / Bank Caving			38.663946 °	38.663946 °
				-121.616453 °	-121.616453 °
DWR ID	DWR_RD0827_01_s_2019_17				
Comment Code					
E2 : Schedule repair of erosion site prior to the next inspection.					
Inspector Comment					
Runoff site through rodent holes.

View of erosion on the waterside slope. Spring 2019.

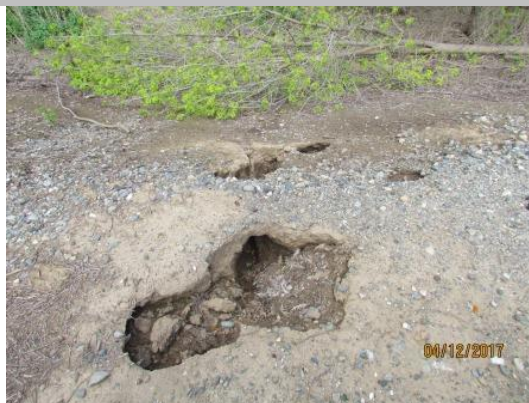
Photo 1 of 3 : SP_2019_RD0827_187_3_20190304_00001.jpg

LM Start	1.12	Rating **	M	Issue No.	3
LM End	1.12	Issue Type +	Ma	Location *	WS
Category	Earthen Levee			GPS Latitude/Longitude	
				Start	End
Item	Erosion / Bank Caving			38.663542 °	38.663542 °
				-121.616056 °	-121.616056 °
DWR ID	DWR_RD0827_01_f_2016_3				
Comment Code					
E2 : Schedule repair of erosion site prior to the next inspection.					
Inspector Comment					
Erosion on the crown and waterside slope from runoff.

View of erosion on waterside levee slope. Spring 2017.

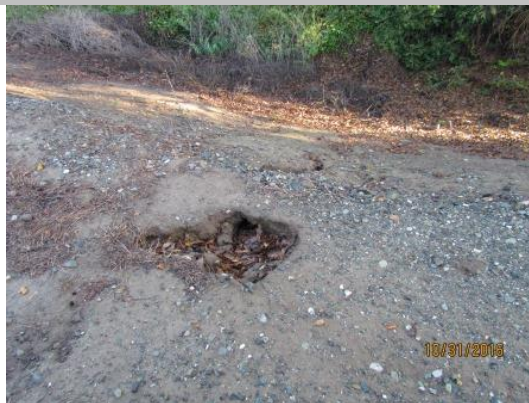
Photo 3 of 3 : SP_2019_RD0827_187_3_20190304_00003.jpg

LM Start	1.12	Rating **	M	Issue No.	3 (cont)	
LM End	1.12	Issue Type +	Ma	Location *	WS	
Category	Earthen Levee			GPS Latitude/Longitude		
				Start		End
Item	Erosion / Bank Caving			38.663542 °	38.663542 °	
				-121.616056 °	-121.616056 °	
DWR ID	DWR_RD0827_01_f_2016_3					
Comment Code						
E2 : Schedule repair of erosion site prior to the next inspection.						
Inspector Comment						
Erosion on the crown and waterside slope from runoff.

View of erosion on crown continuing to WS slope. Fall 2016.

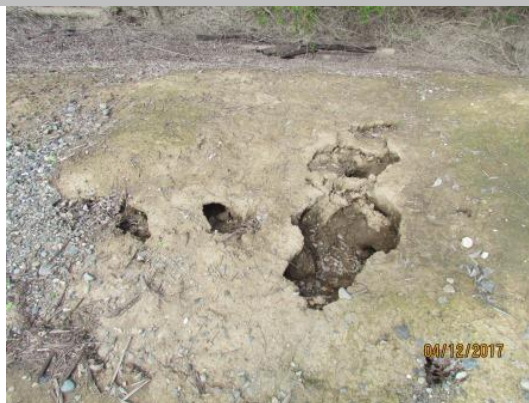
Photo 1 of 1 : SP_2019_RD0827_187_14_20190304_00011.jpg

LM Start	1.14	Rating **	A/W	Issue No.	14
LM End	1.14	Issue Type +	Ma	Location *	WS
Category	Earthen Levee			GPS Latitude/Longitude	
				Start	End
Item	Erosion / Bank Caving			38.663377 °	38.663377 °
				-121.615895 °	-121.615895 °
DWR ID	DWR_RD0827_01_s_2017_14				
Comment Code					
E2 : Schedule repair of erosion site prior to the next inspection.					
Inspector Comment					
Minor erosion on waterside slope. Recommend monitoring

View of erosion on waterside levee slope. Spring 2017.

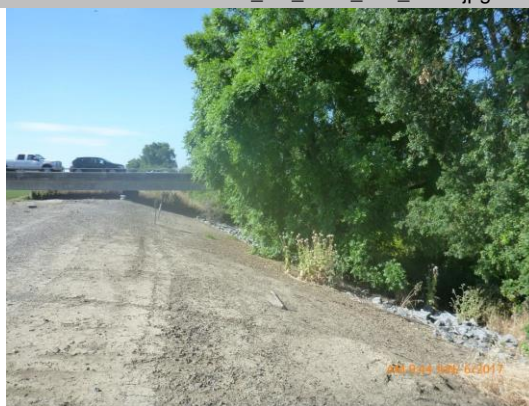
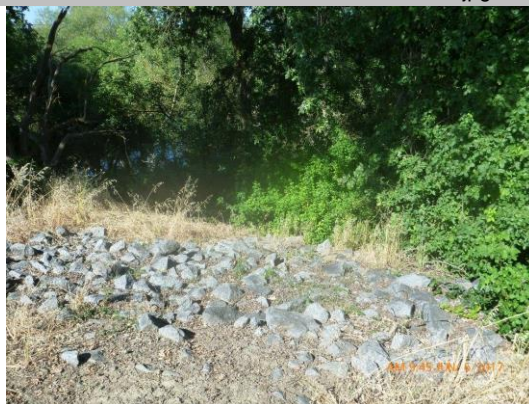
LM Start	0.15	Rating **	A/W	Issue No.	10	
LM End	0.16	Issue Type +	Ma	Location *		
Category	Supplemental			GPS Latitude/Longitude		
				Start	End	
Item	2017 Storm Damage			38.674778 °	38.674583 °	
				-121.642806 °	-121.642722 °	
DWR ID	DWR_RD0827_02_f_2017_10					
Comment Code						
Inspector Comment						
Levee Evaluation Comments						
Description:						
Site ID No:200						
Site Designation:RD 827-02						
Repair Type: Erosion						
Rating:Area of Concern						
Field Date:6/6/2017						
Notes: no damage visible, ws armored with riprap

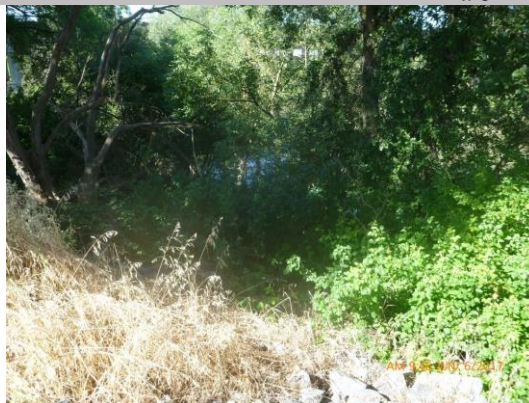
Photo 3 of 3 : LEVAL_SP_2019_200_1246.jpg

LM Start	0.15	Rating **	A/W	Issue No.	10 (cont)	
LM End	0.16	Issue Type +	Ma	Location *		
Category	Supplemental			GPS Latitude/Longitude		
				Start		End
Item	2017 Storm Damage			38.674778 °	38.674583 °	
				-121.642806 °	-121.642722 °	
DWR ID	DWR_RD0827_02_f_2017_10					
Comment Code						
Inspector Comment						
Levee Evaluation Comments						
Description:						
Site ID No:200						
Site Designation:RD 827-02						
Repair Type: Erosion						
Rating:Area of Concern						
Field Date:6/6/2017						
Notes: no damage visible, ws armored with riprap

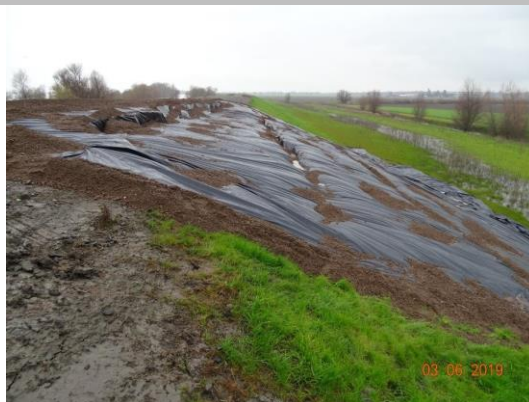
Photo 1 of 1 : SP_2019_RD0827_188_8_20190311_00026.jpg

LM Start	1.94	Rating **	M	Issue No.	8
LM End	1.96	Issue Type +	Ma	Location *	LS
Category	Earthen Levee			GPS Latitude/Longitude	
				Start	End
Item	Slope Stability			38.652232 °	38.651939 °
				-121.627264 °	-121.627088 °
DWR ID	DWR_RD0827_02_s_2019_8				
Comment Code					
S1 : Repair slope instability.					
Inspector Comment					
100' sloughing section on the landside slope. Exposed scarp is approximately 1' at the worst section. LMA placed visqueen over the issue.

View of sloughing on the landside slope. Spring 2019.

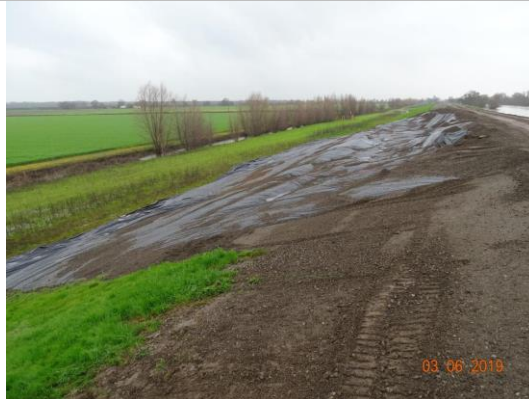
Photo 1 of 1 : SP_2019_RD0827_188_7_20190311_00025.jpg

LM Start	2.09	Rating **	U	Issue No.	7
LM End	2.14	Issue Type +	Ma	Location *	LS
Category	Earthen Levee			GPS Latitude/Longitude	
				Start	End
Item	Slope Stability			38.650245 °	38.649602 °
				-121.626036 °	-121.625646 °
DWR ID	DWR_RD0827_02_s_2019_7				
Comment Code					
S1 : Repair slope instability.					
Inspector Comment					
Sloughing from 2019 storm damage. LMA placed visqueen over the issue.

View of sloughing on the landside slope. Spring 2019.

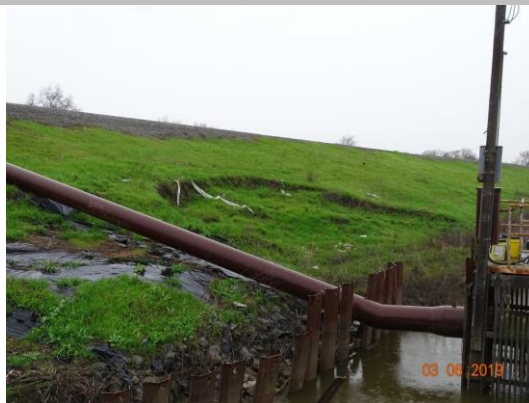
Photo 1 of 4 : SP_2019_RD0827_188_13_20190311_00024.jpg

LM Start	2.72	Rating **	M	Issue No.	13
LM End	2.73	Issue Type +	Ma	Location *	
Category	Supplemental			GPS Latitude/Longitude	
				Start	End
Item	2017 Storm Damage			38.642139 °	38.642028 °
				-121.620750 °	-121.620667 °
DWR ID	DWR_RD0827_02_f_2017_13				
Comment Code					
Inspector Comment					
Levee Evaluation Comments					
Description:					
Site ID No:199					
Site Designation:RD 827-01					
Repair Type: Erosion					
Rating:Area of Concern					
Field Date:6/6/2017					
Notes: landside. Sloughing on the landside slope near pump.					
Movement has stabilized and the LMA will be constructing a setback levee within the next 3 years. Recommend monitoring.

View of sloughing on the landside slope. Spring 2019.

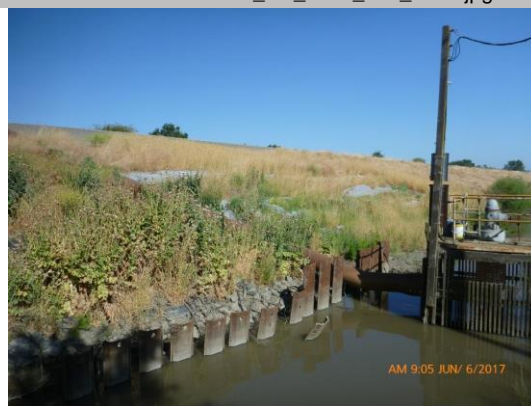
Photo 3 of 4 : LEVAL_SP_2019_199_1232.jpg

LM Start	2.72	Rating **	M	Issue No.	13 (cont)
LM End	2.73	Issue Type +	Ma	Location *	
Category	Supplemental			GPS Latitude/Longitude	
				Start	End
Item	2017 Storm Damage			38.642139 °	38.642028 °
				-121.620750 °	-121.620667 °
DWR ID	DWR_RD0827_02_f_2017_13				
Comment Code					
Inspector Comment					
Levee Evaluation Comments					
Description:					
Site ID No:199					
Site Designation:RD 827-01					
Repair Type: Erosion					
Rating:Area of Concern					
Field Date:6/6/2017					
Notes: landside. Sloughing on the landside slope near pump.					
Movement has stabilized and the LMA will be constructing a setback levee within the next 3 years. Recommend monitoring.

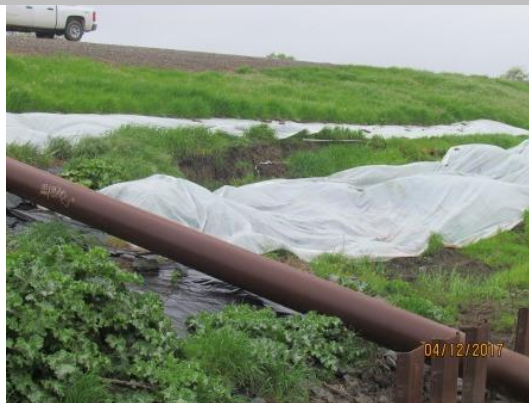
Photo 1 of 2 : SP_2019_RD0827_188_14_20190304_00010.jpg

LM Start	2.72	Rating **	A/W	Issue No.	14
LM End	2.72	Issue Type +	Ma	Location *	LS
Category	Earthen Levee			GPS Latitude/Longitude	
				Start	End
Item	Slope Stability			38.642018 °	38.642018 °
				-121.620944 °	-121.620944 °
DWR ID	DWR_RD0827_02_s_2017_14				
Comment Code					
S1 : Repair slope instability.					
Inspector Comment					
Sloughing on the landside slope near pump. Movement has stabilized.

View of sloughing and visqueen on landside levee slope. Spring 2017.

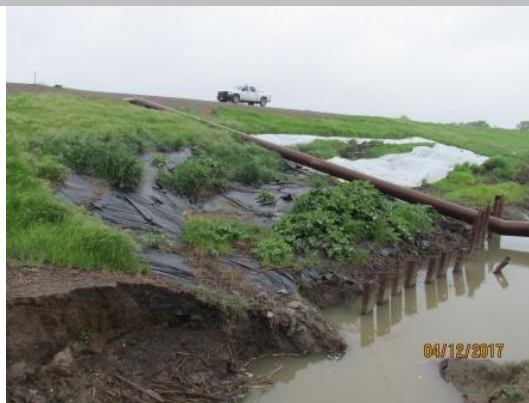
Photo 2 of 2 : SP_2019_RD0827_188_14_20190304_00011.jpg

LM Start	2.72	Rating **	A/W	Issue No.	14 (cont)
LM End	2.72	Issue Type +	Ma	Location *	LS

Additional view of sloughing on landside levee slope. Spring 2017.
